9. Non destructive inspection of sintered metal crack

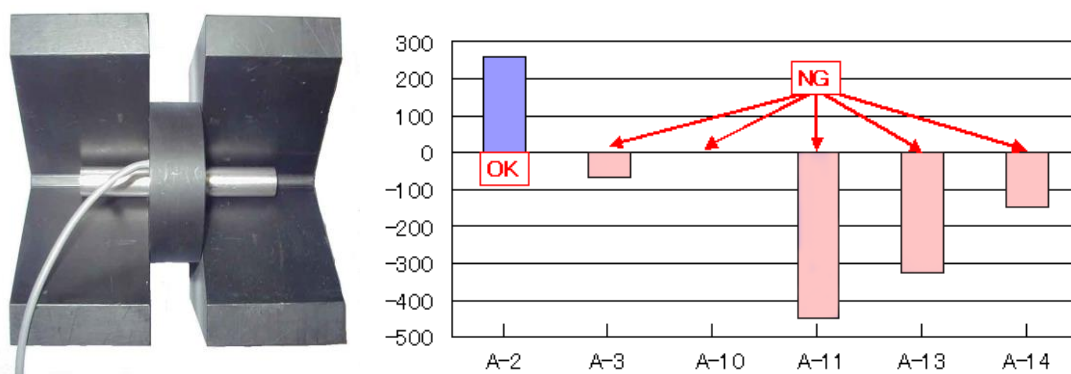
Putting the sintered metal rod (12×80) into the middle of the ring-sensor, sintered metal crack is inspected. At A-2 the MDK-value shows clearly positive with the qualified rod, the non-qualified rods instead show minus, so that the qualification distinction can be made very easily.
