1. Detecting defects on a steel pipe covered with heat insulating material

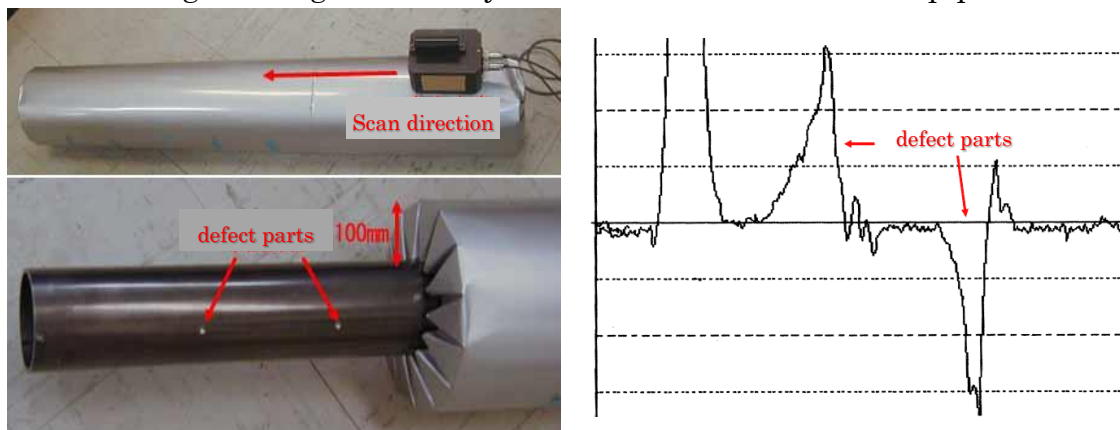
Non-destructive inspection is conducted by a large square type sensor to detect defects on a steel pipe covered with 100mm thick insulating material. This insulating material is covered with 1mm thick metal plate.

The result is that two defect points are confirmed on the graph. This clarifies that the magnetism generated by the sensor reaches the steel pipe.
